Another Conservation Success Story...

Chattahoochee County, Georgia

July 2006

River of Mud Becomes a Stream of Traffic

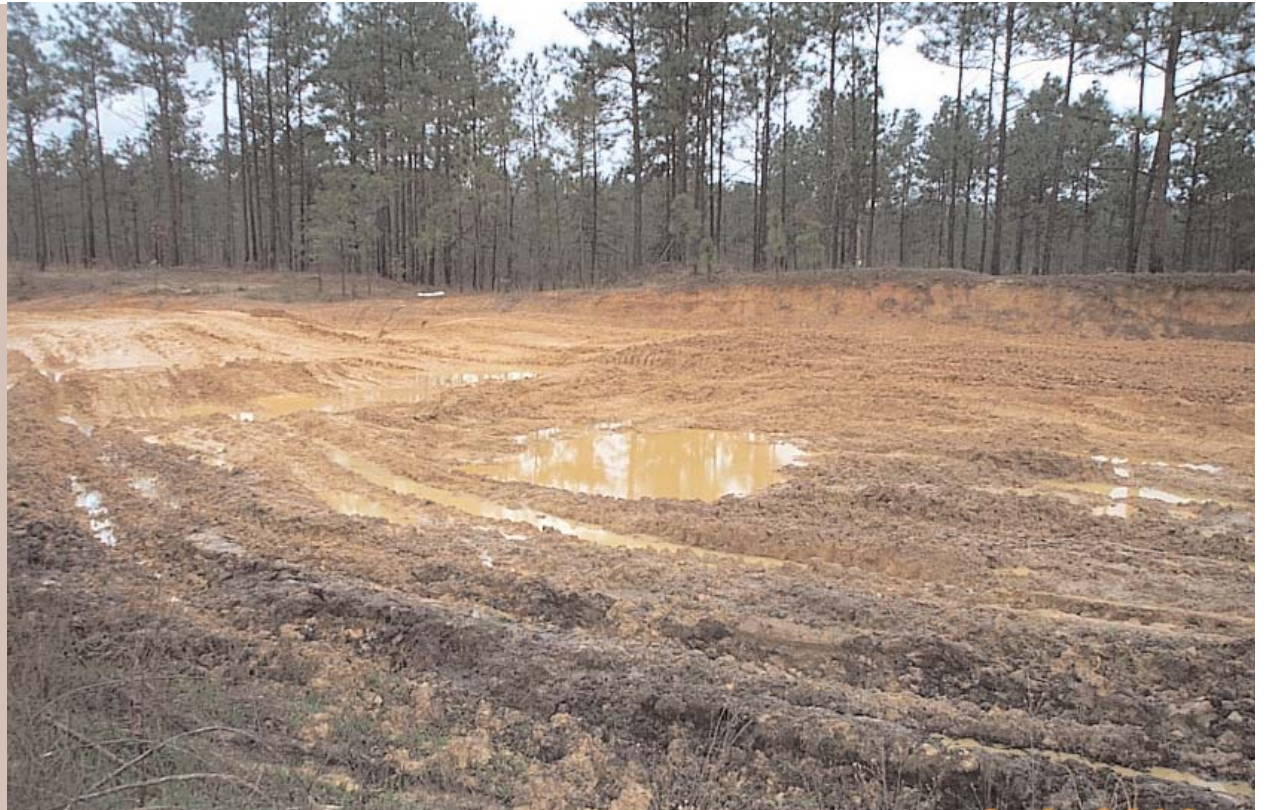
Even the armored vehicles themselves are steered around the deepest ruts and gullies, expanding the problem. When it rains, these trails can literally become a river of mud.

The tank trail in the A7 Training Compartment was a prime example of where an especially bad segment of the trail was located adjacent to Martin Range.

Even though it was a primary travel route out to the mechanized training areas, over time the severity of the damage and concerns for safety forced all traffic to be detoured to a longer secondary route. Routine maintenance per-

Before - March 6, 2003

The NRCS was asked to assist in permanently correcting the damage and stabilizing the site to provide all-weather access for mechanized vehicles. After a thorough investigation of the site, a plan was developed by NRCS and the representatives of the Army to remedy the problem.

To stabilize the site, it was first necessary to remove approximately 2 feet of unconsolidated mud and soil.

Once the sub-grade preparation was complete, a 12 inch layer of No.3 coarse aggregate stone was put down on a geotextile fabric to form a foundation.

The coarse aggregate stone also provided drainage relief for wet weather seepage. This stone was then covered with 9 inches of finely graded aggregate base material, crowned, and compacted to provide a smooth durable two lane driving surface.

The ditches, shoulders and road banks were reshaped to provide for stable surface drainage and all disturbed areas were vegetated.

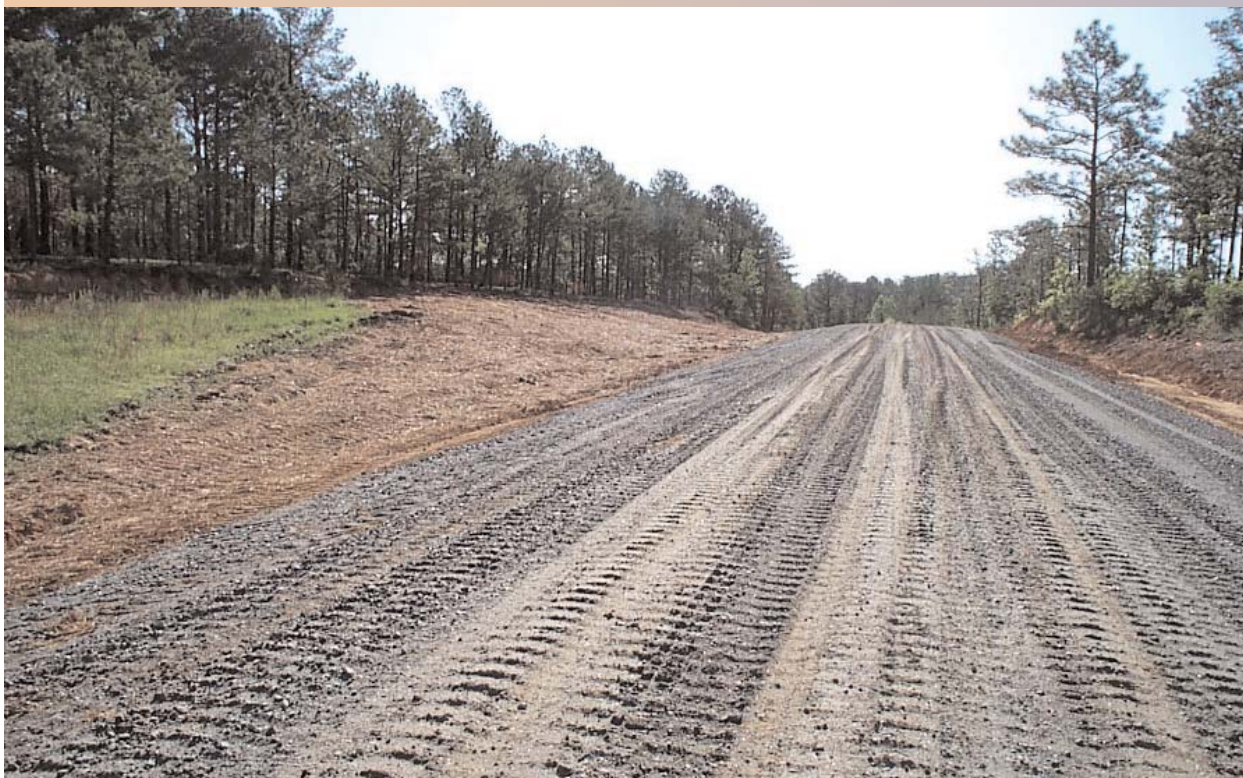
By extending NRCS's traditional concept of heavy use protection to accommodate the foot print of a 60 ton tank, the A7 tank trail is back in use and is holding up well in all types of weather.

After - April 22, 2003
